Identifying Locations for Pedestrian and Bicyclist Safety Improvements in Chapel Hill and Carrboro, North Carolina

Final Report to
North Carolina Department of Transportation,
Traffic Engineering and Safety Systems Branch
December 2008, Revised July 2009

University of North Carolina
Highway Safety Research Center

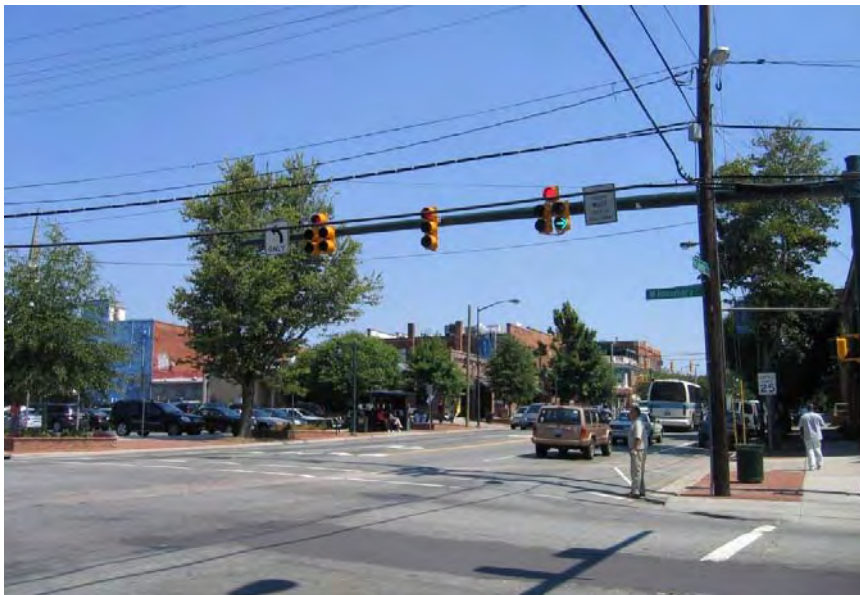
Figure 24. Utility lines obscure regulatory signs and traffic signals; pavement markings are worn and paved over at Columbia and Franklin St.

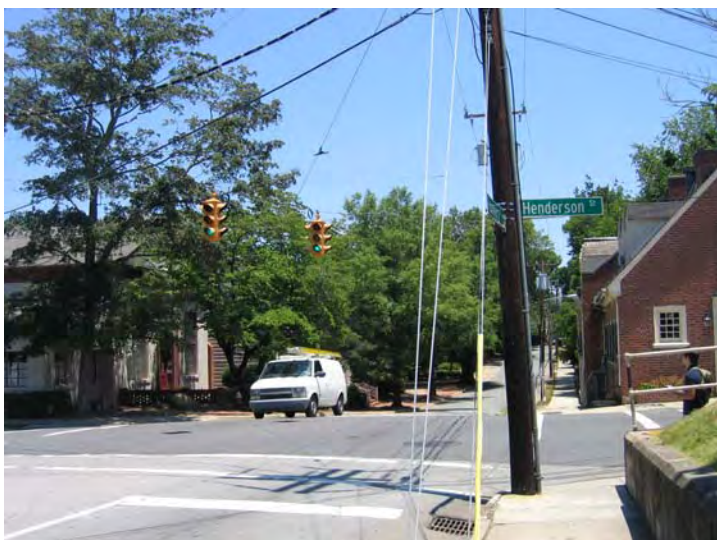
Figure 25. Pedestrian signals are lacking; utility pole narrows useable space and may obstruct visibility; curb is nearly level with the street, with no detectable ramp for pedestrians with disabilities at the corner of Rosemary and Henderson Sts.

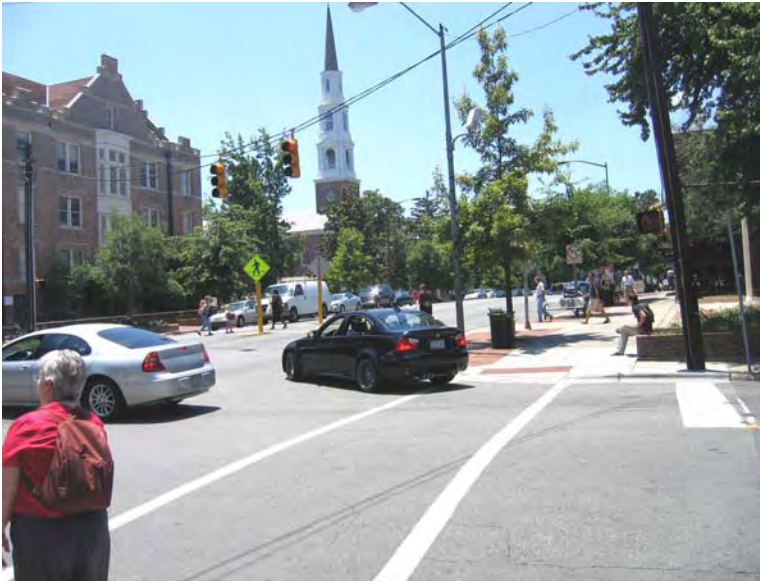
Figure 26. West side crosswalk on Franklin (crosswalk in the background with fluorescent yellow pedestrian warning sign) at Henderson St is set back from the intersection.

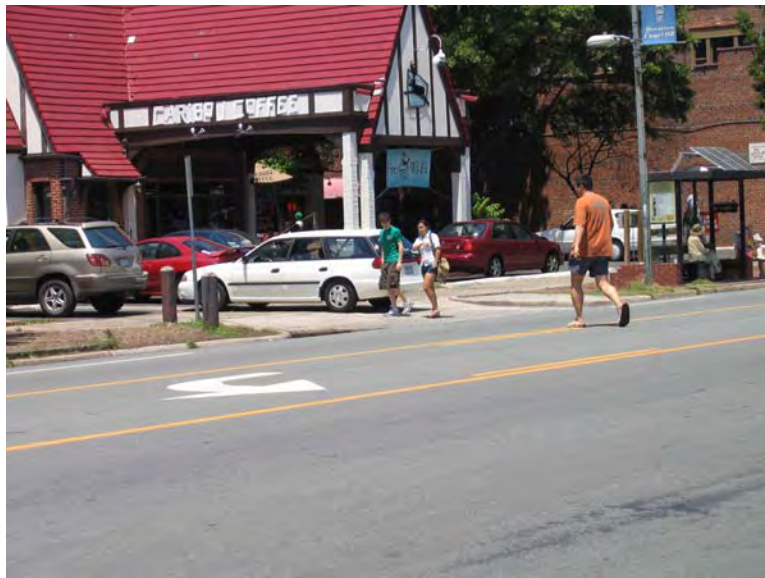
Figure 35. Pedestrians cross midblock to businesses and transit stops on opposite sides of Franklin St, west of Columbia St.

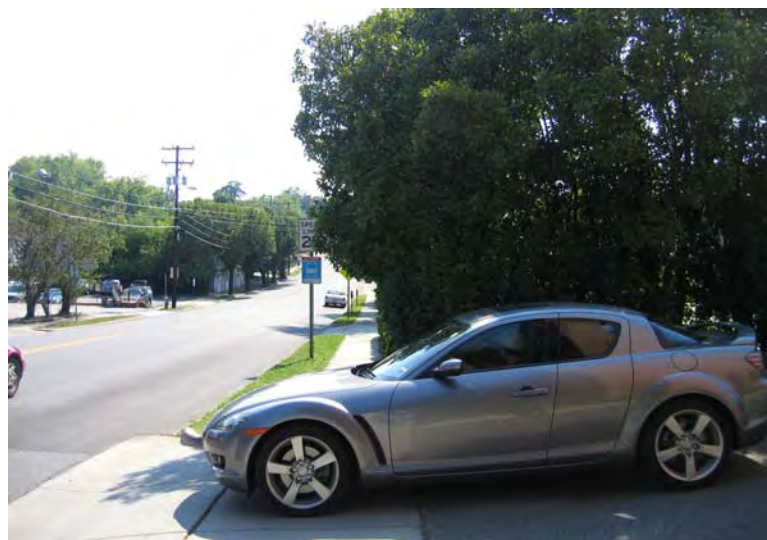
Figure 37. View of pedestrians, bicyclists, or oncoming motorists is blocked by shrubbery at this alley connecting with Rosemary St.

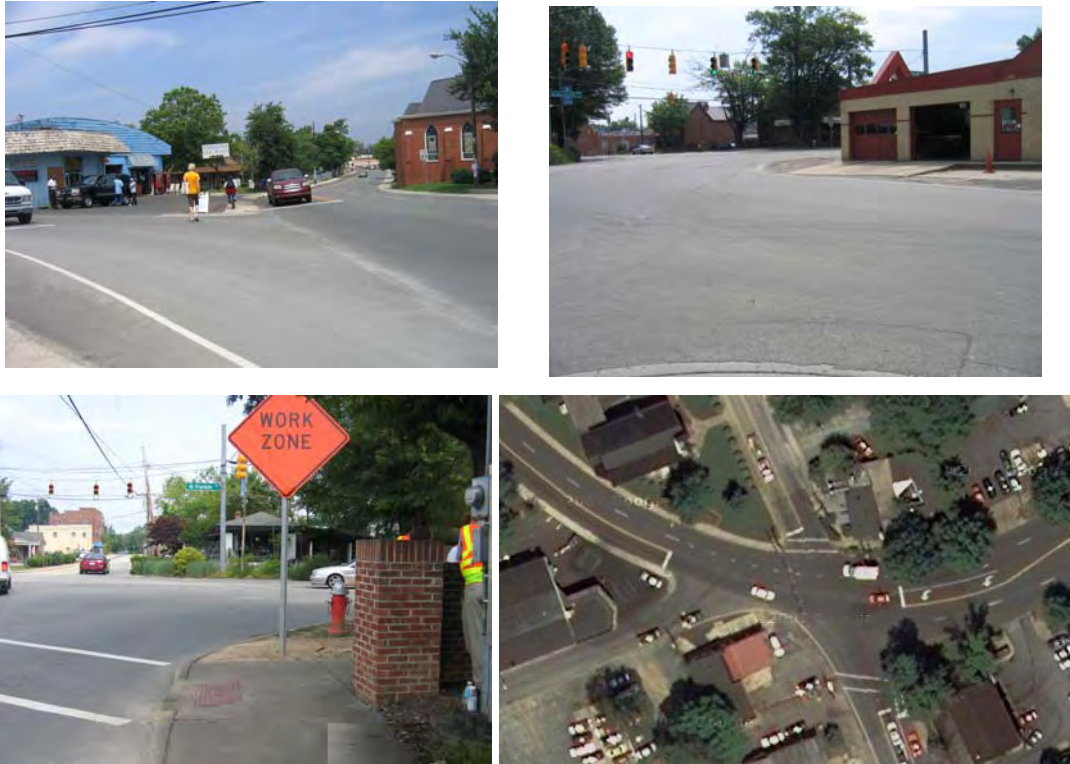
Figure 39. The multi-leg intersection of Franklin, Main, Merritt Mill, and Brewer provides a large expanse of unmarked pavement for pedestrians, cyclists, and motorists to navigate. (Lower right image from Google Imagery © 2008 U.S. Geological Survey.)

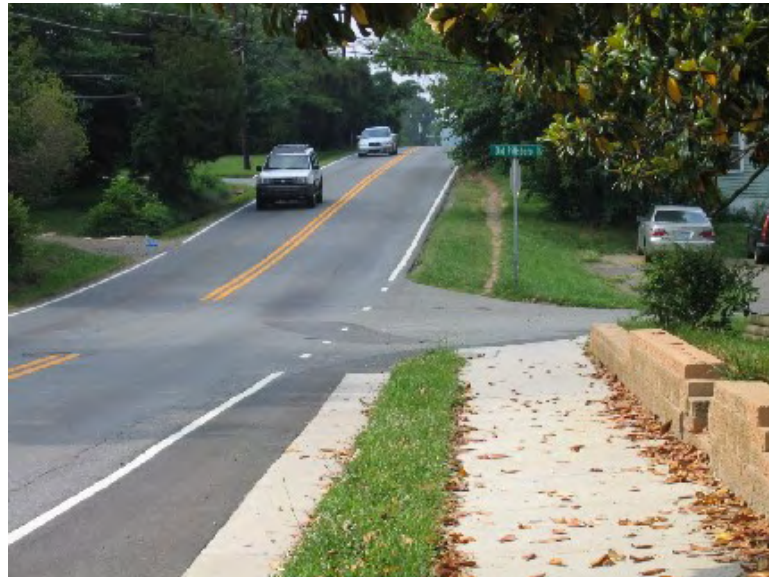
Figure 45. View of S Greensboro south of Carr St. Note the beaten path beyond where the sidewalk ends at Old Pittsboro.

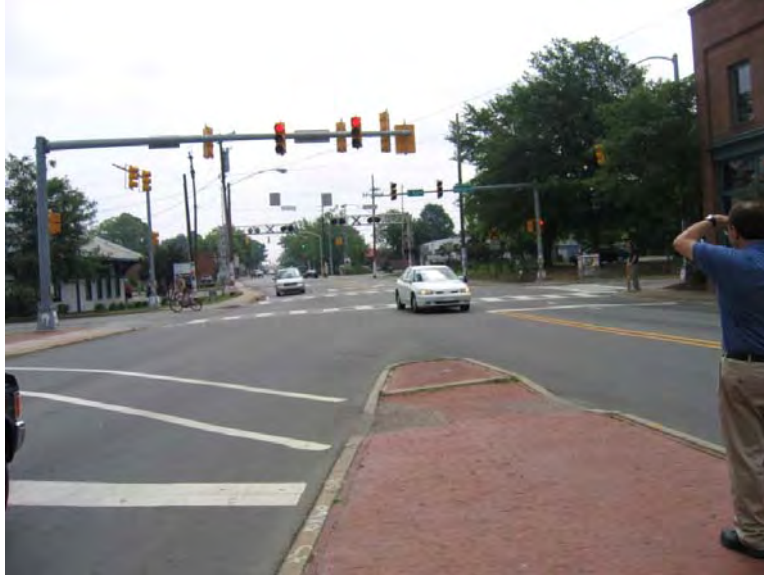
Figure 47. Second crosswalk crossing to center of triangle bounded by Main and Weaver St has no pedestrian signal; pedestrians may not be able to recognize when it is safe to cross.

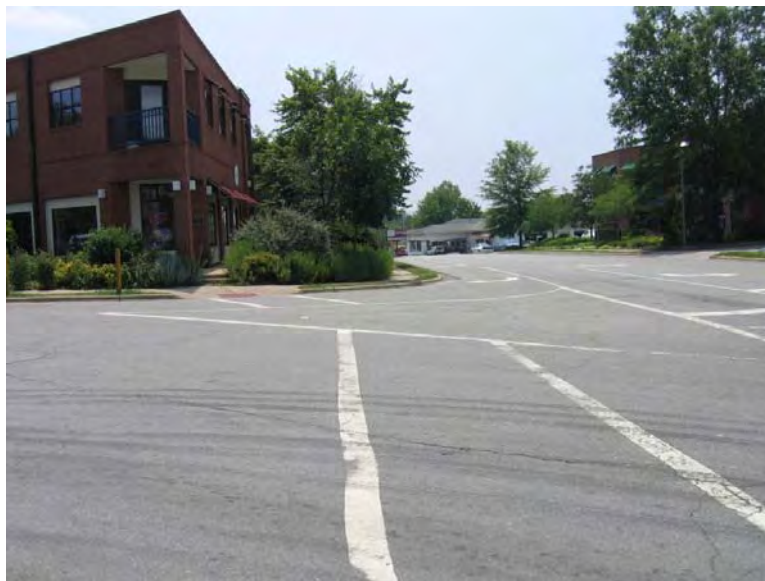
Figure 49. Wide expanse of pavement with only 'paint' for refuge. Two legs of the intersection lack pedestrian walk signals.

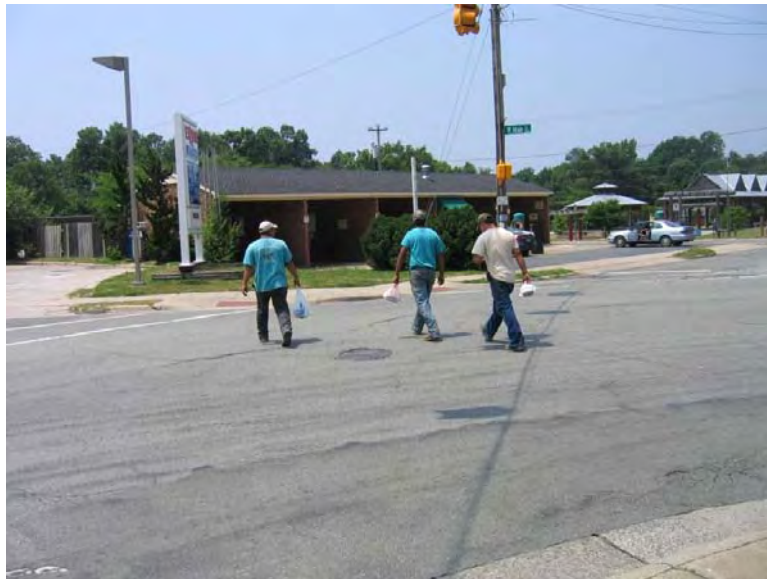
Figure 51. Pedestrians tend to take the shortest route between two points and should not be expected to cross extra legs of intersections in order to use crosswalks or pedestrian signals.

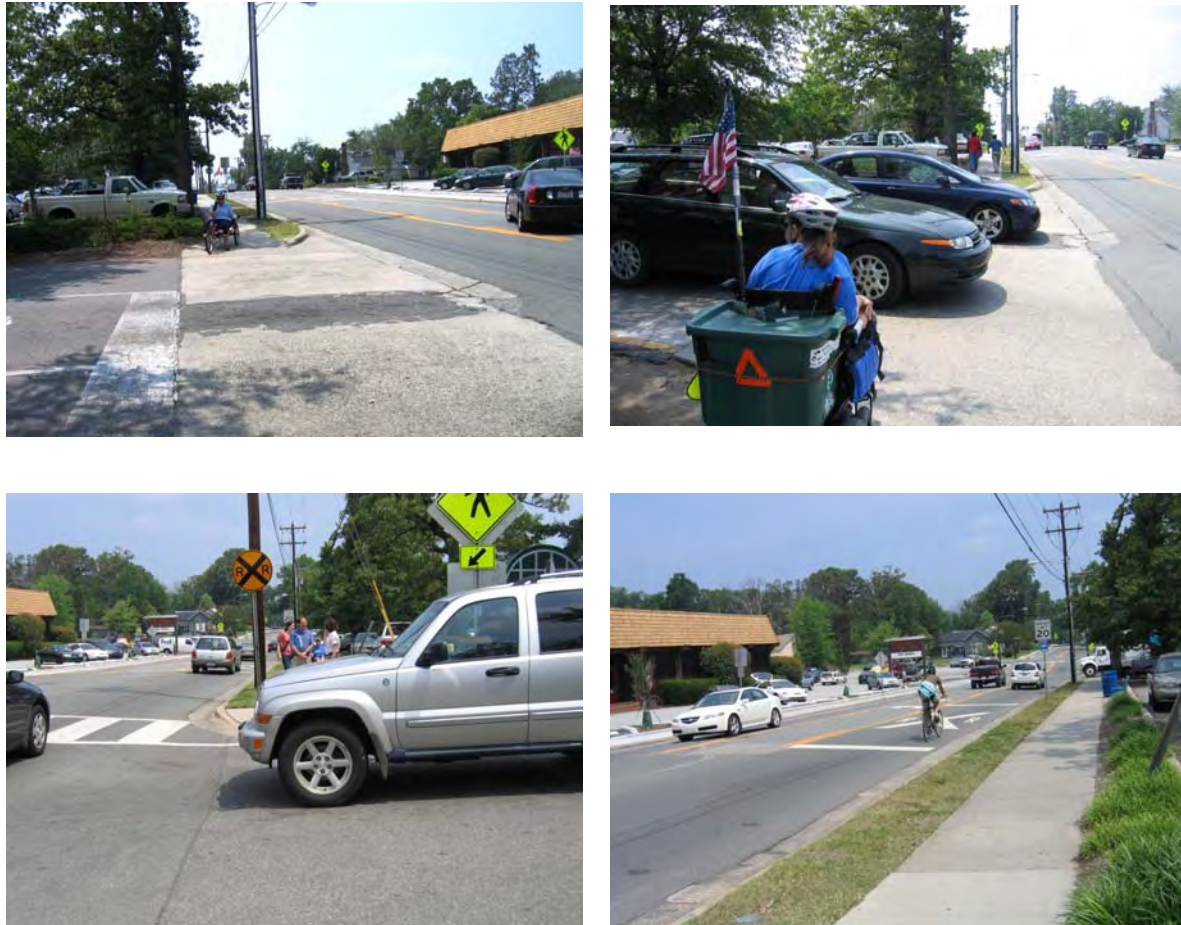
Figure 52. Pedestrians and bicyclists may struggle with vehicles turning in and out of driveways, even where crosswalks are marked across N Greensboro St.

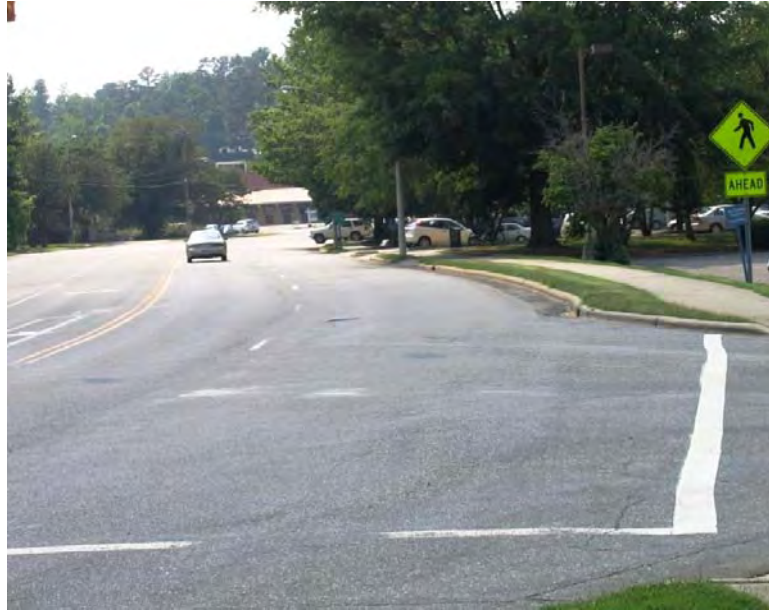
Figure 54. Estes Dr showing part of intersection with Willow Dr (and missing crosswalks) and views of driveways west and area where pedestrians often cross midblock.

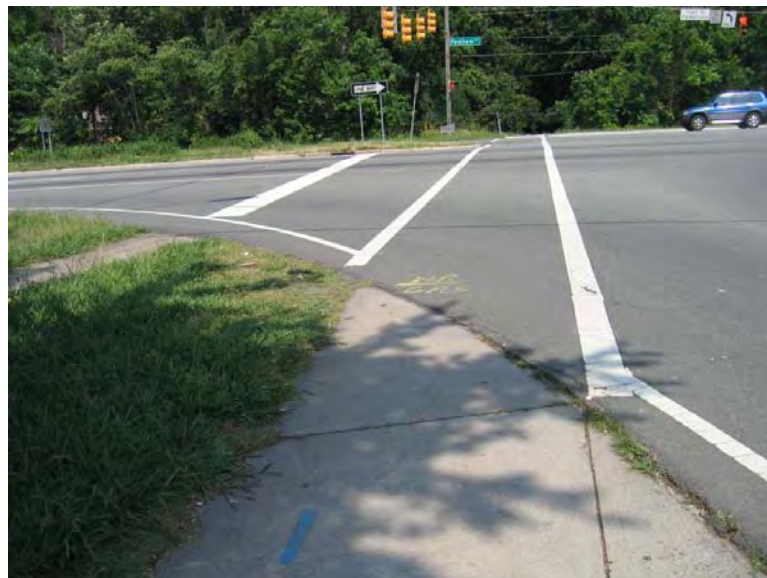
Figure 55. A lack of a curb and wide turn radius may allow high-speed turns from southbound Fordham onto Estes.

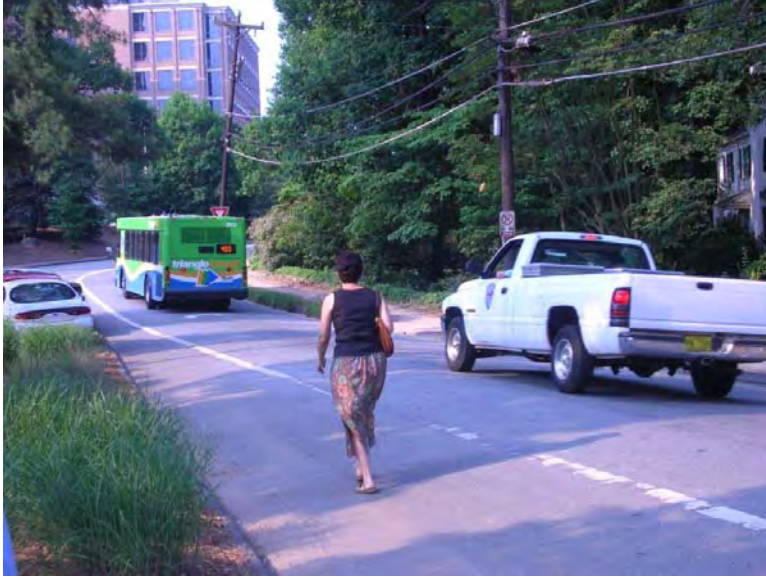
Figure 61. There is no sidewalk on the west side of Pittsboro across from the traffic island.

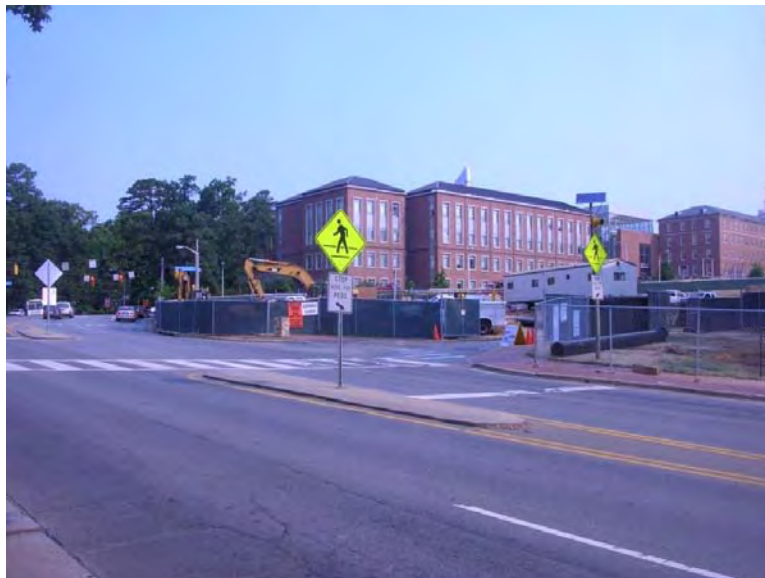
Figure 62. Closing sidewalks may result in extra roadway crossings and increased exposure for pedestrians. (Photo by Charlie Zegeer)

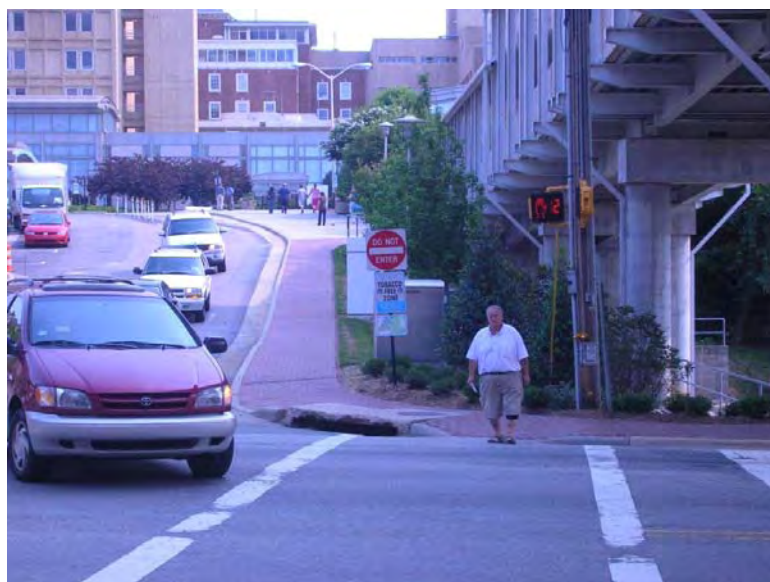
Figure 63. Motorists failing to yield when turning is a frequent cause of pedestrian collisions at intersections on Manning Dr.

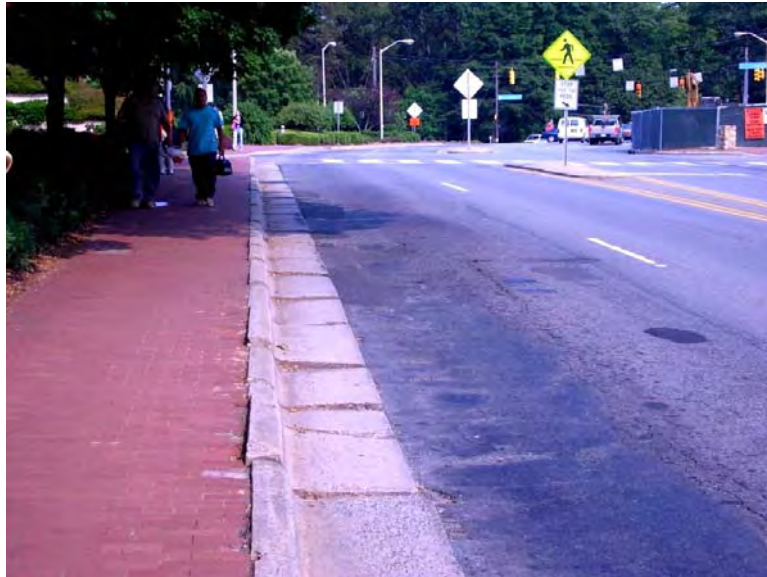
Figure 64. Sidewalk and curbs are extensively damaged in some areas along Manning Dr. Sidewalks on the west end are also immediately adjacent to traffic lanes. (Photo by Charlie Zegeer)

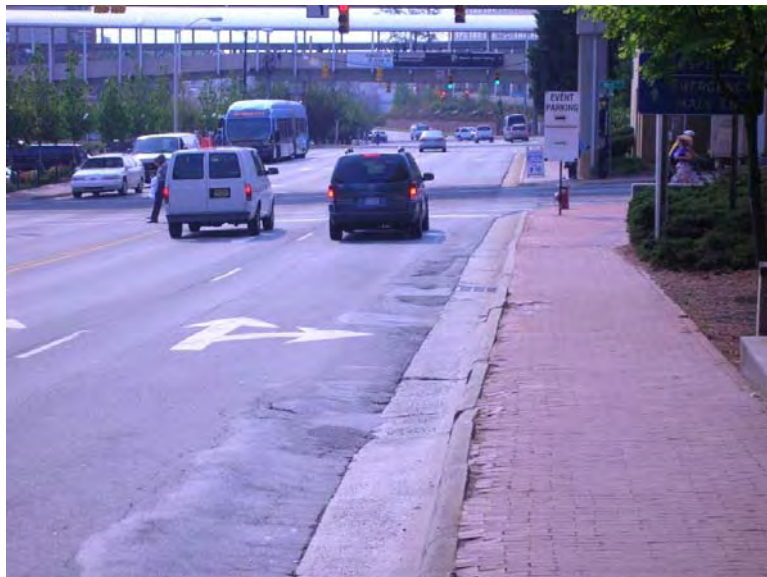
Figure 65. Right lane pavement in the area where bicyclists would ride is also very rough from heavy vehicle/transit use. Both pavement and sidewalks are in need of repair. (Photo by Charlie Zegeer)

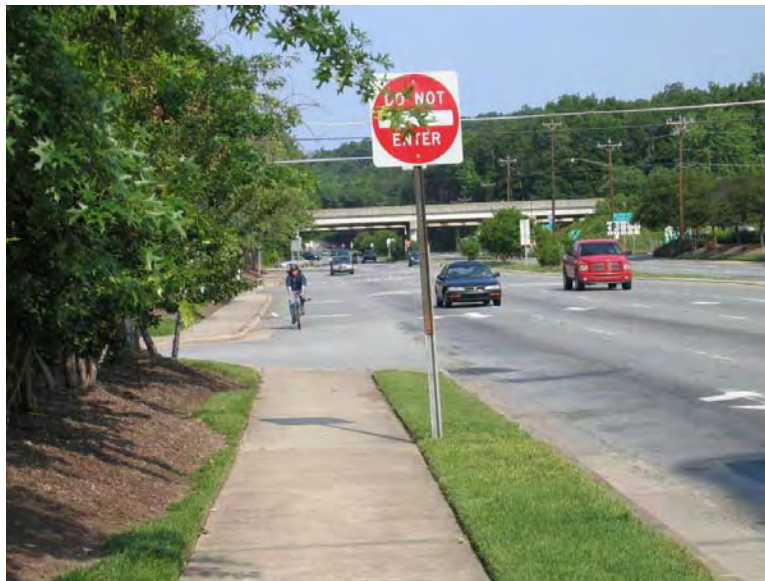
Figure 68. Eastbound Raleigh Rd looking toward 15/501 interchange areas and shopping center driveway (foreground) and merge areas.

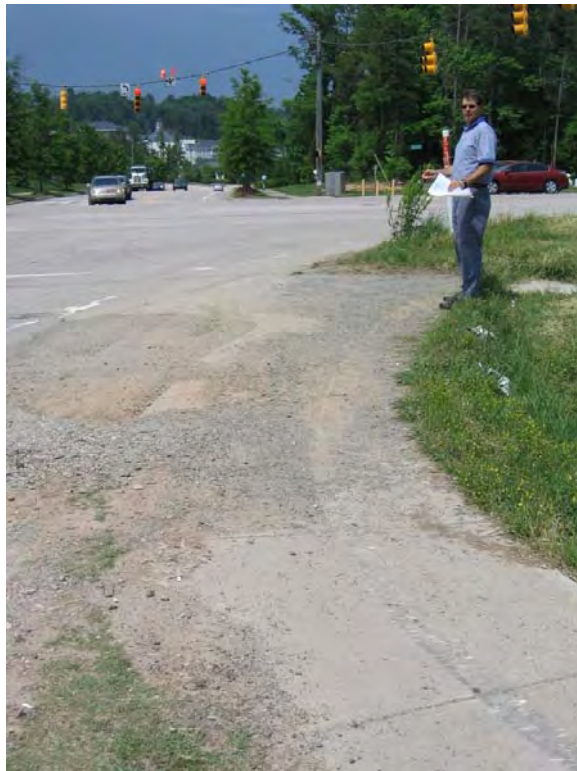
Figure 73. There is no curb and poor delineation between the road and pedestrian pathway at south side of Raleigh Rd and Barbee Chapel E.

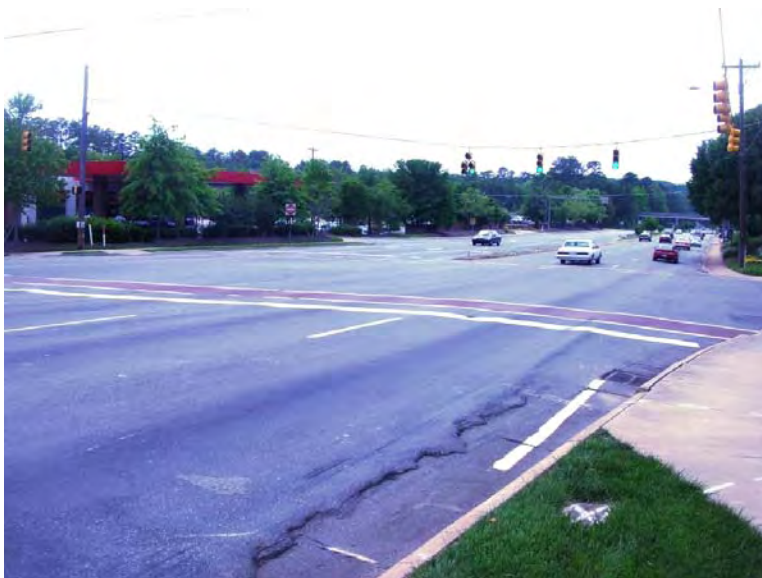
Figure 76. Rough pavement near the right side of the lane is hazardous for bicyclists (near Hamilton intersection).

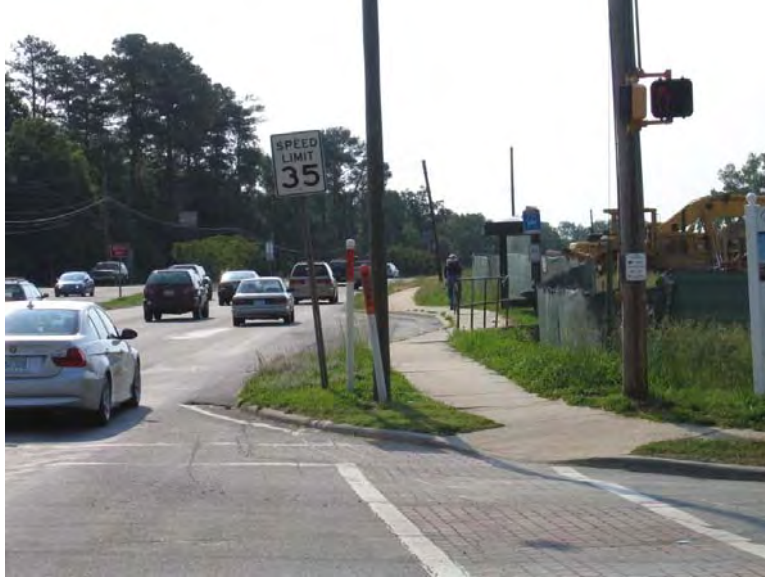
Figure 77. Bicyclist choosing to ride on the sidewalk, which ends ahead, during a heavy traffic time.
