Identifying Locations for Pedestrian and Bicyclist Safety Improvements in Chapel Hill and Carrboro, North Carolina

Final Report to
North Carolina Department of Transportation,
Traffic Engineering and Safety Systems Branch
December 2008, Revised July 2009

University of North Carolina
Highway Safety Research Center

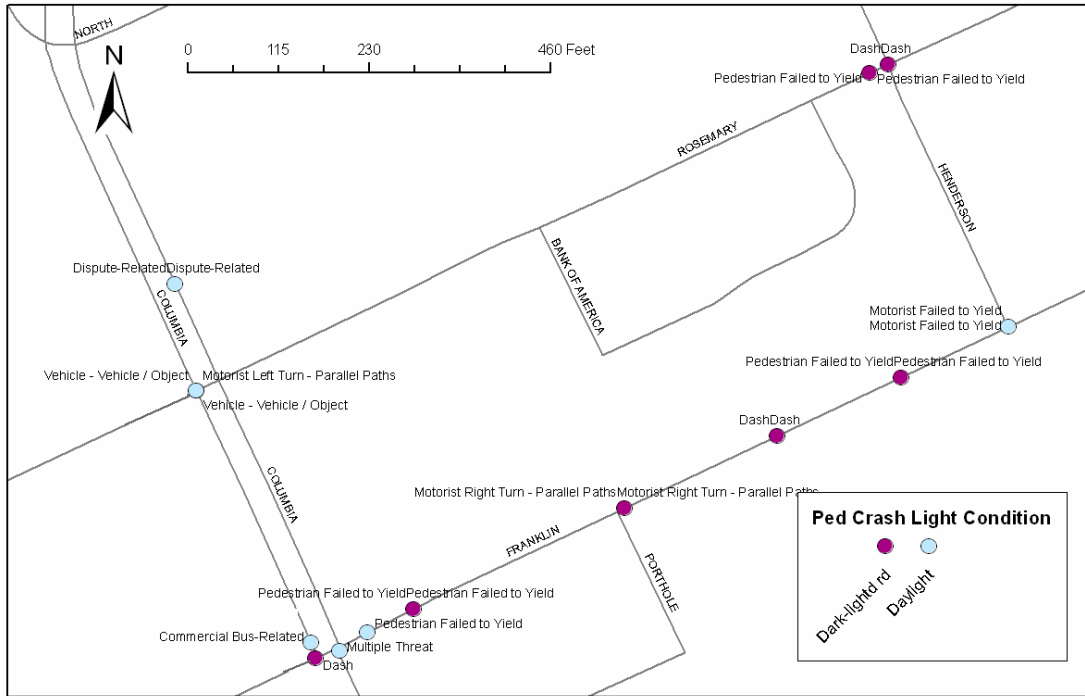
Figure 23. Downtown East Chapel Hill audit area and pedestrian crashes.

Ten of the 14 pedestrian collisions in this audited area occurred at night (Figure 23) even though Franklin St seems to be well-populated with street lights. However, pedestrian level sidewalk lighting could enhance the security and traffic safety of downtown by allowing motorists to notice pedestrians still on the sidewalks and enliven the nighttime pedestrian environment. About half of the collisions occurred at intersections and half at midblock locations.

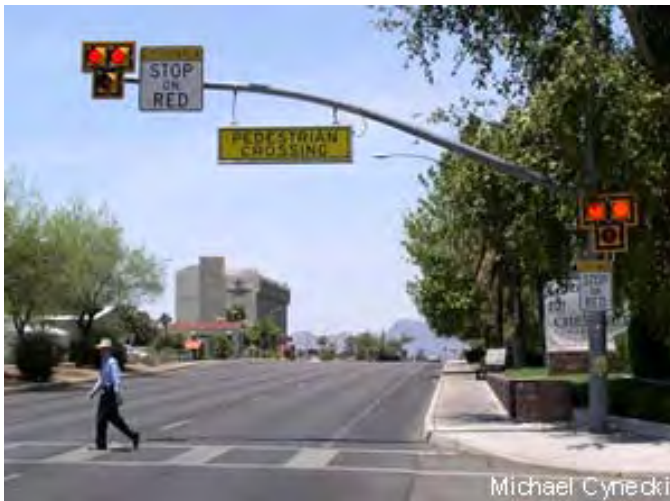
Figure 27. A HAWK signal provides a pedestrian-activated, stop-controlled crossing at midblock locations or other locations that do not warrant a regular traffic signal. (Photo by M. Cynecki)

A fully accessible midblock crossing island could be considered for some area along this section of Rosemary St (between Columbia St and Henderson St). A midblock crossing could provide a refuge area for those who need it, particularly older and younger pedestrians, parents pushing strollers, and pedestrians with disabilities. Use of a HAWK signal activated by pedestrians would give pedestrians a protected crossing (similar to a regular traffic signal) but only stops traffic when pedestrians are present (Figure 27). The HAWK pedestrian hybrid signal is approved for the next version of the MUTCD.

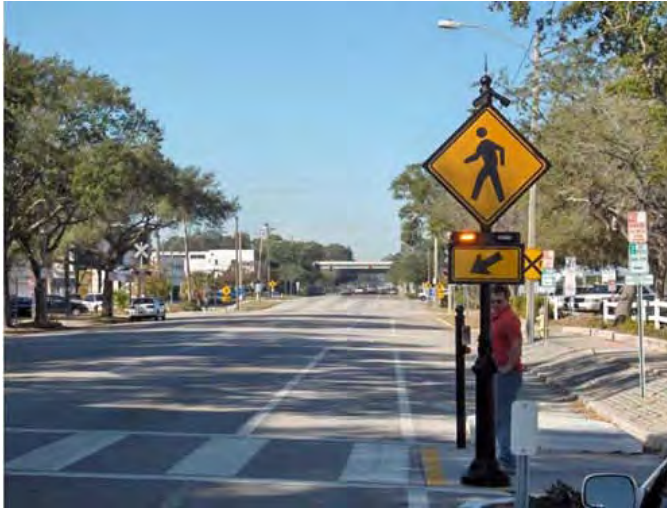
Figure 28. The rapid-flash beacon has also been evaluated for multi-lane crosswalks and has achieved a high rate of yielding over a sustained time period (Van Houten and Malenfant, n.d. Image from Van Houten and Malenfant).

- ⇒ An alternative to the HAWK signal is the rapid flash (“stutter”) beacon which has been found to increase yielding compliance, also slated for approval in the next MUTCD edition (Figure 28). The rapid flash beacon has achieved the highest yielding rates of any non-red signal indication, and costs considerably less than the HAWK (Van Houten and Malenfant, n.d.).

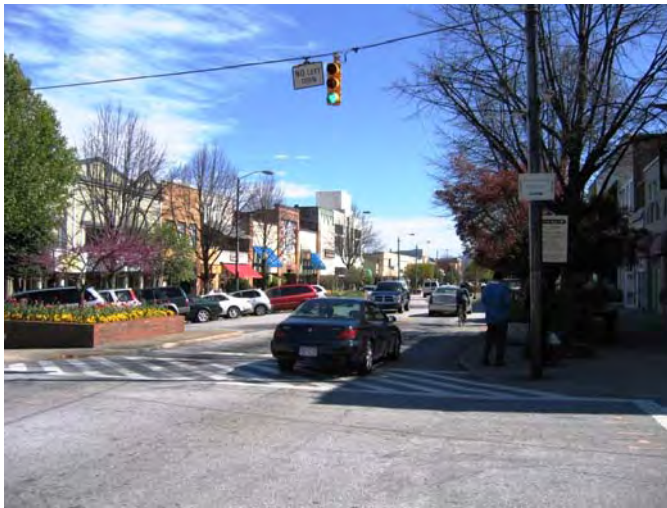
Figure 29. Downtown Hendersonville, NC streets have bulb-out sidewalk extensions. (Photo by Austin Brown)

High-visibility crosswalks and two-lane streets with on-street parking help to create a low-speed urban environment.

- ⇒ See suggestion in the following section regarding a road diet to create a slower Franklin St that could be more comfortably shared by both pedestrians and bicyclists – and move cyclists away from the “door zone” and other conflicts. Bulb-outs, special parking treatments, and other features could also be used to foster low-speed downtown streets appropriate for a central business district (See images in Figure 29, Figure 30). Creating a shifting alignment (chicane) through alternating parking, for example could slow speeds. Back-in or reverse angle parking ensures that motorists are facing out with a view of on-coming traffic when leaving parking, and could increase the number of parking spaces. Back-in angle parking also eliminates the “dooring” type of bicycle crash (Figure 31). See BIKESAFE for further description of these treatments (Hunter et al. 2006).

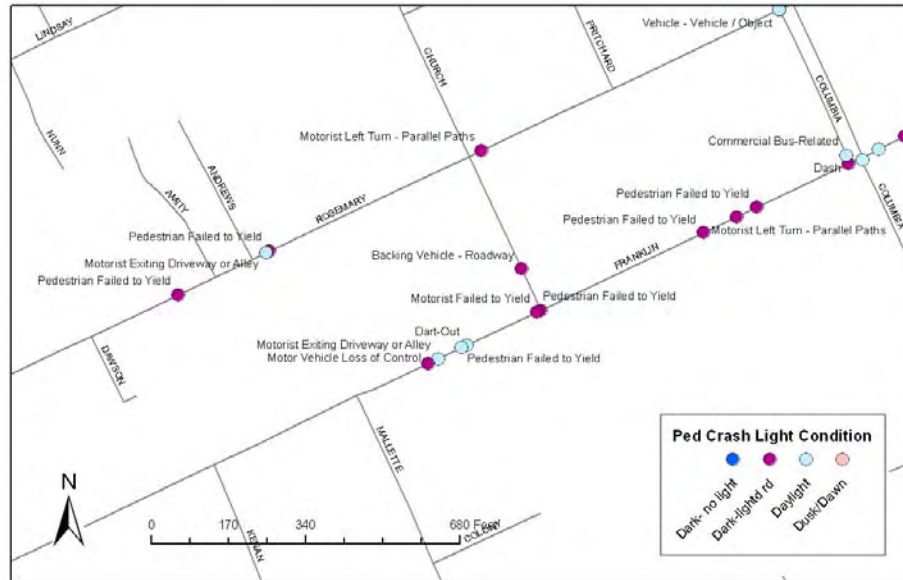
This area includes W Rosemary St (from Columbia), Columbia between Franklin and Rosemary and W Franklin St from Columbia to just west of Kenan St (see Figure 33). Speeds are significantly higher than the posted 20 mph, with 85th percentile speeds measured at 34 mph near Mallette St.

Figure 33. Downtown West Chapel Hill audit area and pedestrian crash locations. Midblock pedestrian crashes were prevalent in this area on both Franklin and Rosemary St. More than half of the pedestrian crashes also occurred at night.

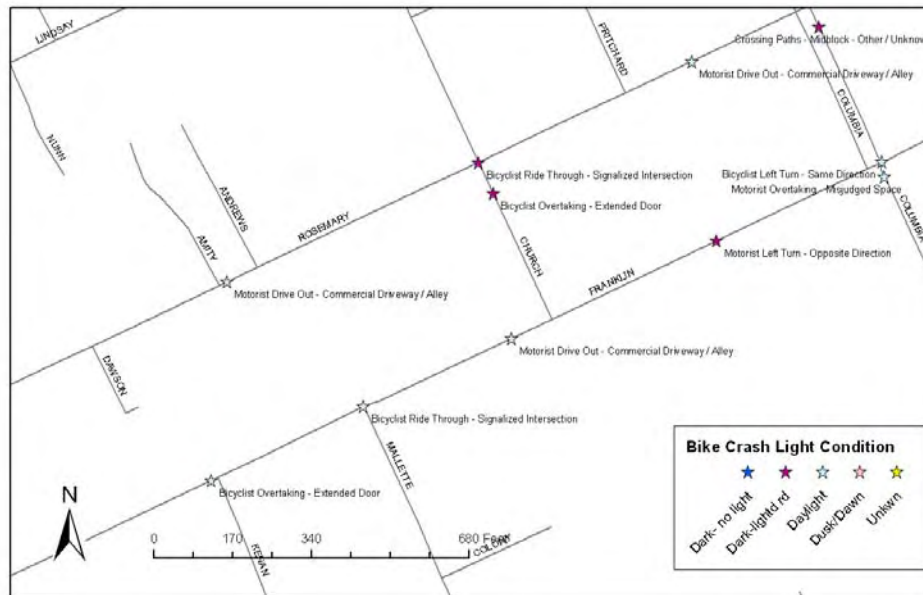
Figure 34. Downtown West Chapel Hill audit area and locations of bicyclist crashes. Four of 11 bicycle collisions also occurred at night and were a mix of types of collisions at intersections, driveways, and non-junction locations.

- Four bicycle collisions occurred in this section along Franklin St (Figure 34). Collisions have occurred when motorists turned left in front of on-coming cyclists and drove out without yielding, both at driveways. In the drive-out, the bicyclist may have contributing by traveling wrong-way in the roadway. One bicyclist struck a door of a parked vehicle that was opened into his path (eastbound just west of Kenan St).

- ⇒ Consider adding signs to parking meters in areas with on-street parking to remind motorists to check behind for traffic before opening car doors facing the street and before parking or pulling back into the traffic stream.
- ⇒ Educate bicyclists to ride in the direction of traffic (on the street); avoid the door zone in parking areas; take the lane in narrow lane, low speed situations; use proper lighting and retro-reflective gear at night and dusk/dawn; and wear safety helmets and obey all traffic signs and signals.

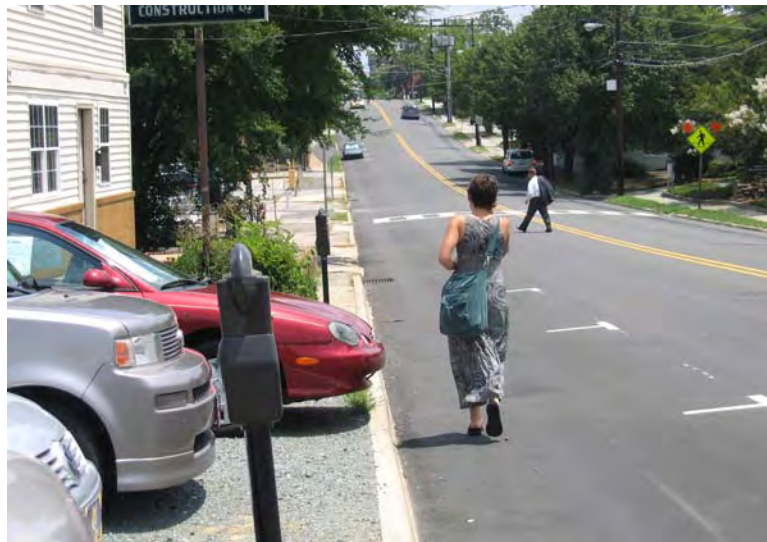
- Availability, width, and quality of sidewalks through the study site are inconsistent and generally lacking continuity. Pedestrians were observed to have to walk in the street in some locations (see Figure 36 for an example). Pedestrians with disabilities would probably have to travel in the street for much of its length. Many of the curbs along the study site are deteriorating, and they are almost at the same level as the street. The result is a very low degree of separation between pedestrian and vehicle spaces.

Figure 36. Pedestrians must enter the roadway to skirt parking meters and vehicles parked adjacent to Rosemary St. When the on-street spaces are occupied, pedestrians may have to walk in the middle of the traffic lane.

In the distance, another pedestrian crosses outside of the uncontrolled midblock crosswalk (with fluorescent yellow warning).

- ⇒ Complete sidewalks on both sides of street; repair poor, irregular, surfaces of existing walkways. Ideally, provide wider sidewalks (6 feet or wider) separated by a buffer from traffic. Our understanding is that sidewalk improvements for Rosemary St are pending.

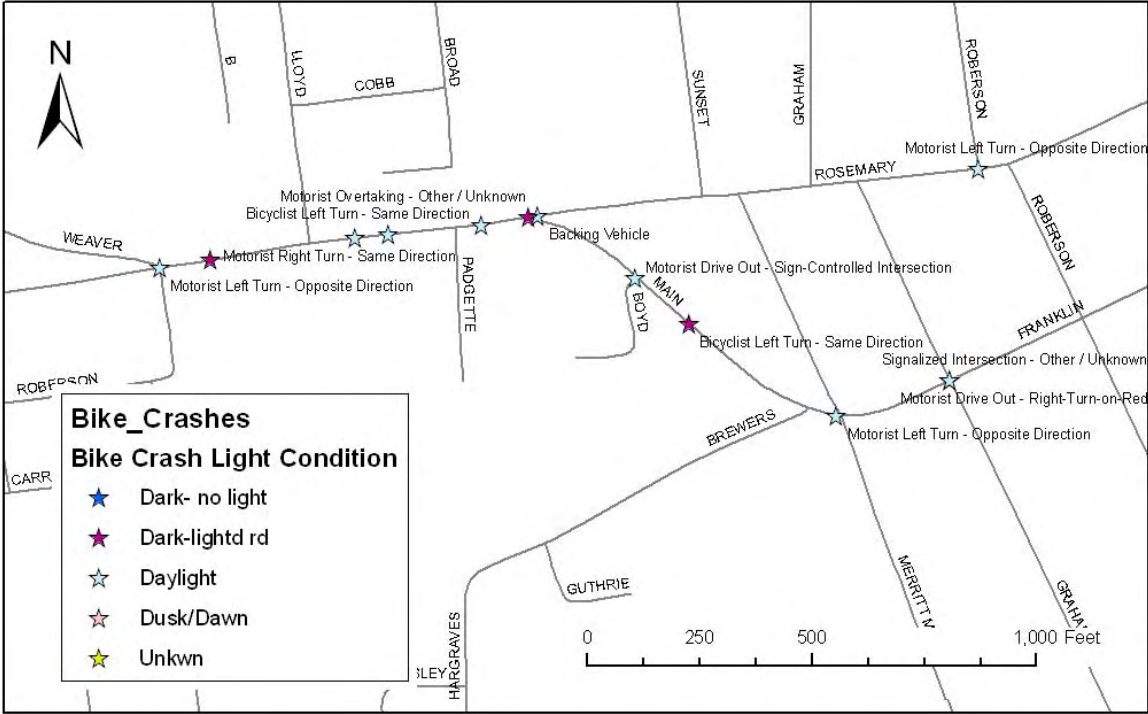
Seven of the bicycle collisions occurred at intersections with 5 at midblock or driveway locations. Three of the collisions occurred after dark, but roadways were considered lighted (Figure 38).

Figure 38. Chapel Hill- Carrboro transition area and bicycle crashes.

The crashes mostly involved motorist drive outs from driveways or stop-controlled intersections, and/or turning left and right across the path of through bicyclists without yielding to bikes. In most cases, the cyclist was riding on the sidewalk, but only two cases involved wrong-direction riding. Two overtaking motorists struck bicyclists traveling in a travel lane in the correct direction. Two bicyclists attempting to merge or turn left rode into the path of a motorist; one of these was a ride out from the sidewalk. Thus, the collisions suggest that this is a challenging roadway whether one is riding on the street in the direction of traffic, or opting for the sidewalk. One pedestrian collision occurred at Rosemary and Main during the study period. Several other pedestrian collisions occurred nearby on Roberson St, on Rosemary St near Graham, and on Brewers near the intersection, but no clear patterns emerged.

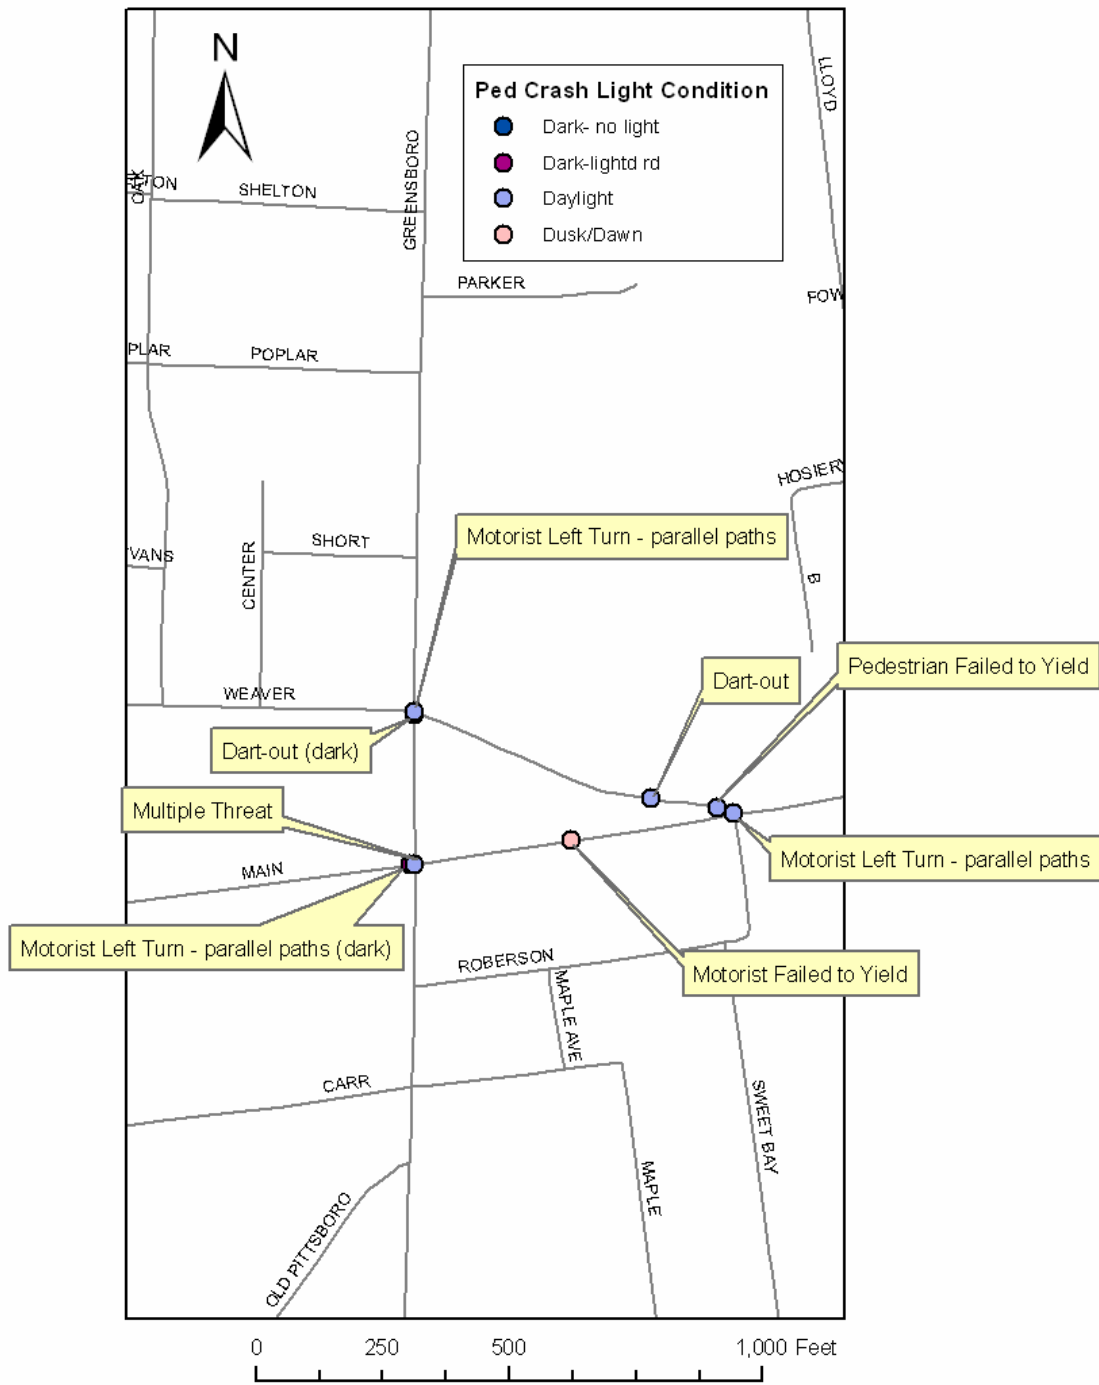
Figure 43. Downtown Carrboro audit area and pedestrian collisions.

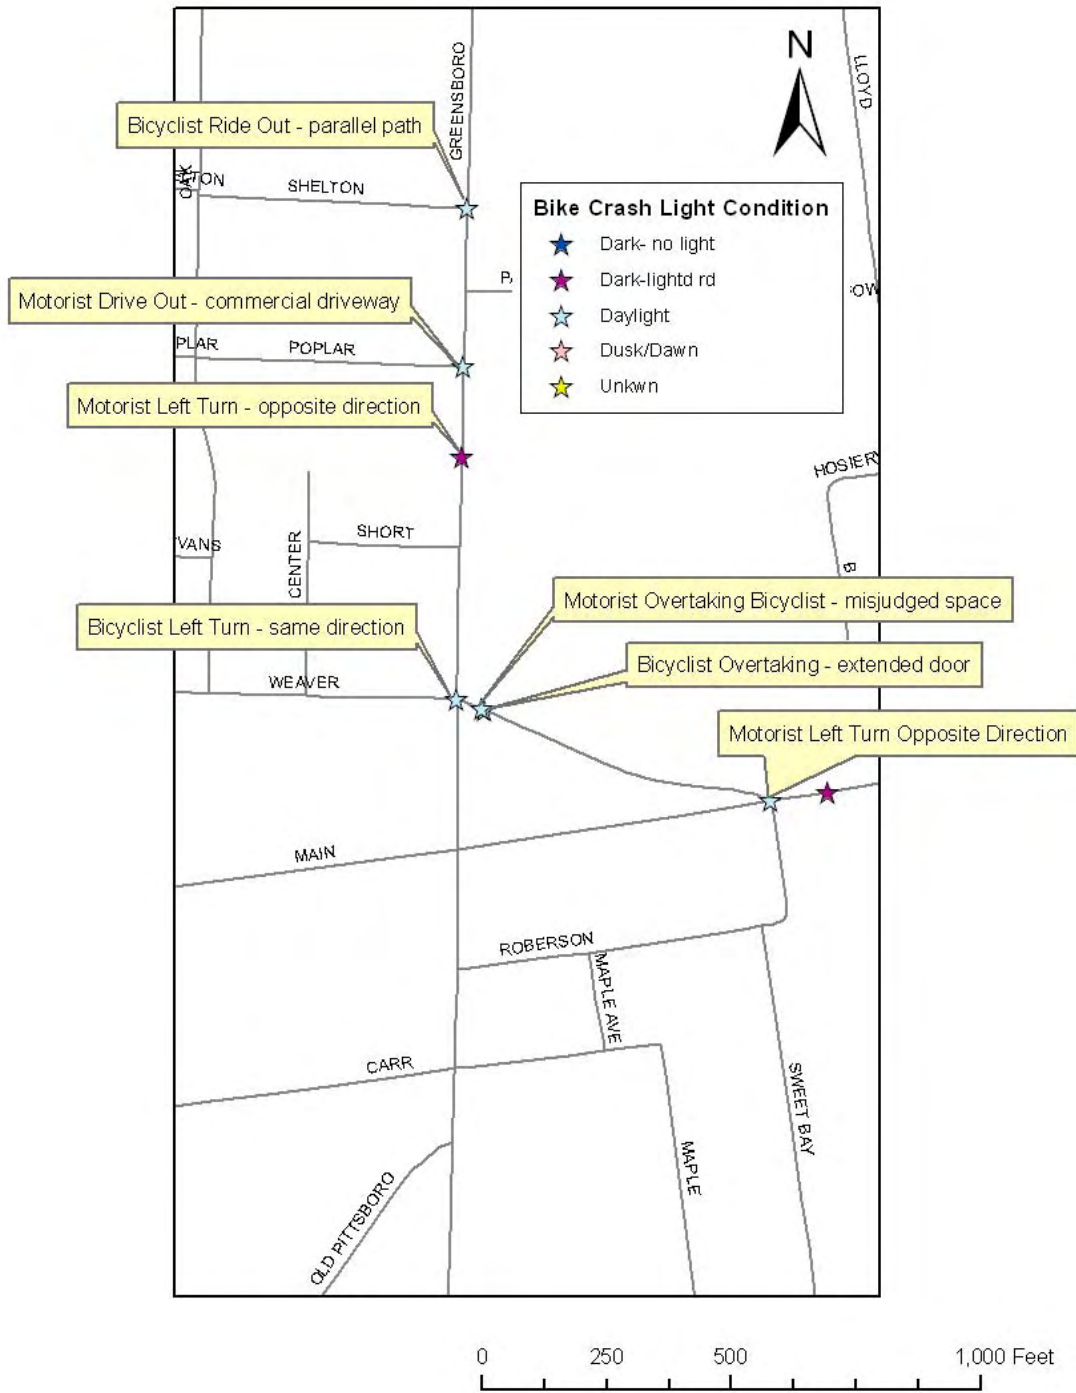
Figure 44. Downtown Carrboro audit area and bicycle collisions.

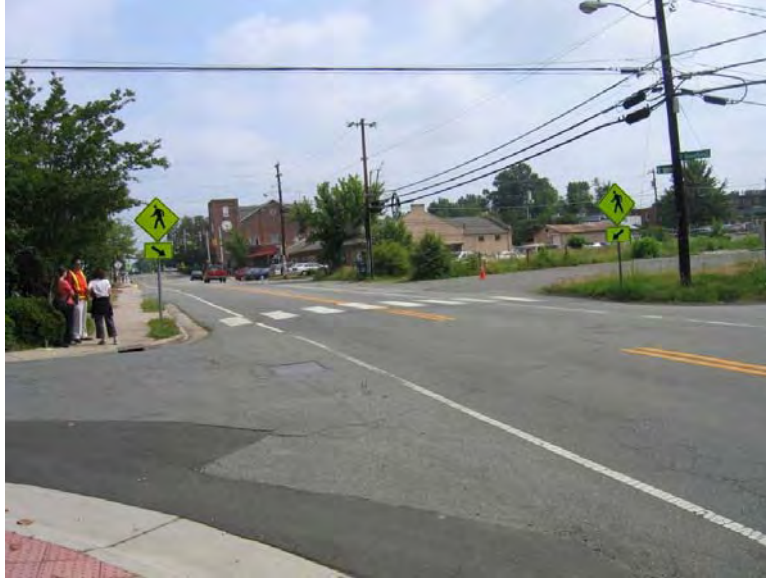
This intersection was identified by the Town of Carrboro. There is a high visibility crosswalk and high visibility warning signs at this uncontrolled location on S Greensboro St (with stop control for Carr), but no traffic or pedestrian signals. The Town reports complaints that motorists do not yield to pedestrians trying to cross at this location. There are likely perception issues on the part of motorists since most of this section, from Main St (Old Pittsboro on the west side), south to beyond the NC 54 bypass, lacks sidewalks. Motorists approaching this crosswalk probably have the impression that they are in a semi-rural area (see Figure 45). A speed study on S Greensboro (south of Old Pittsboro) found that motorists (northbound and southbound) are traveling at 50th percentile speeds of 39 mph and 85th percentile speeds of 44 mph. Although the speed limit is reduced from 35 to 20 prior to reaching this junction, it is unlikely that motorists have much incentive to slow down before Carr St. Studies have found that motorists traveling at speeds above 20 mph are increasingly unlikely to slow or yield at uncontrolled crosswalks. There are no crosswalks across Carr, either side, and no crosswalk on the south side on Greensboro (Figure 46).

Figure 46. View of Carr St crosswalk on S Greensboro.

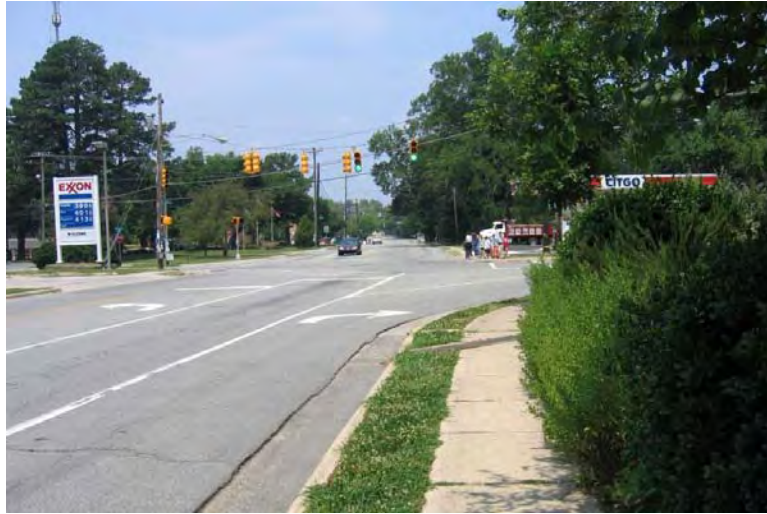
- There is a continuous flow, right-turn lane on westbound Main where sight-distance of the crosswalk is obscured due to crosswalk placement (in the middle of the turn) and to vegetation (see Figure 50).

Figure 50. Crosswalks across right-turn flow lanes should be prior to the curve of the turn. On NW-bound W Main at W Weaver, shrubbery also obscures the view of the crosswalk.

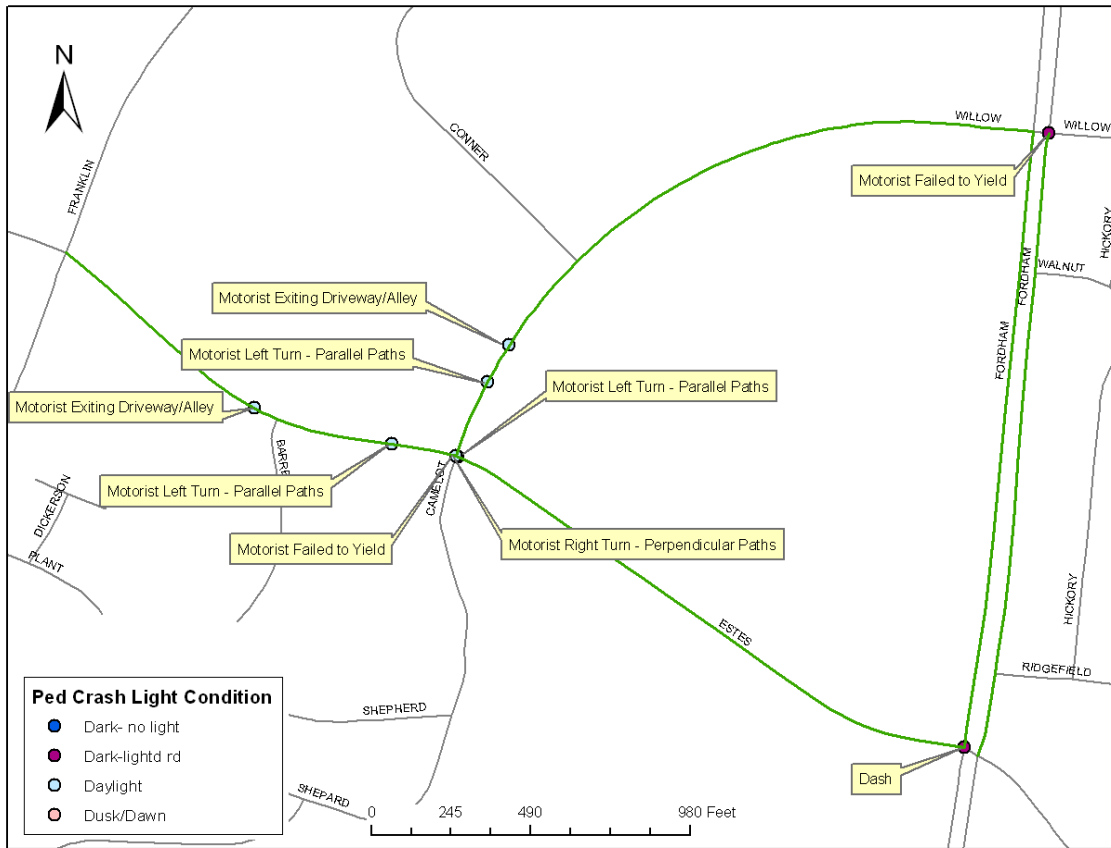
Given the substantial pedestrian and bicycle traffic and number of generators in this area, and the number of collisions that have already occurred (see Figure 53), this would seem to be a priority area for improving safety and providing amenities for both bicyclists and pedestrians. The intersections of Franklin and Estes, and to a lesser extent Fordham and Estes, were also highlighted by perception data for pedestrians.

Figure 53. Estes Dr audit area and pedestrian crash locations.

A single marked crossing at Willow Dr is the only crossing between Franklin St (> 0.3 mi distant) and Fordham Blvd (> .25 mi distant). Three pedestrian crashes were reported at this intersection (2nd highest number for any intersection, Figure 53). All three of the crashes occurred during daylight conditions. One collision involved a hit-and-run motorist and a pedestrian using a wheel chair. All three of the collisions were a result of motorists failing to yield to pedestrians. Two crashes involved motorists turning east onto Estes from Willow and striking pedestrians in the crosswalk area. The third crash involved a motorist on Willow in the straight/right-turn lane striking a pedestrian coming from the motorist's right (eastbound). This collision involved a hit-and-run driver, so further details are sketchy.

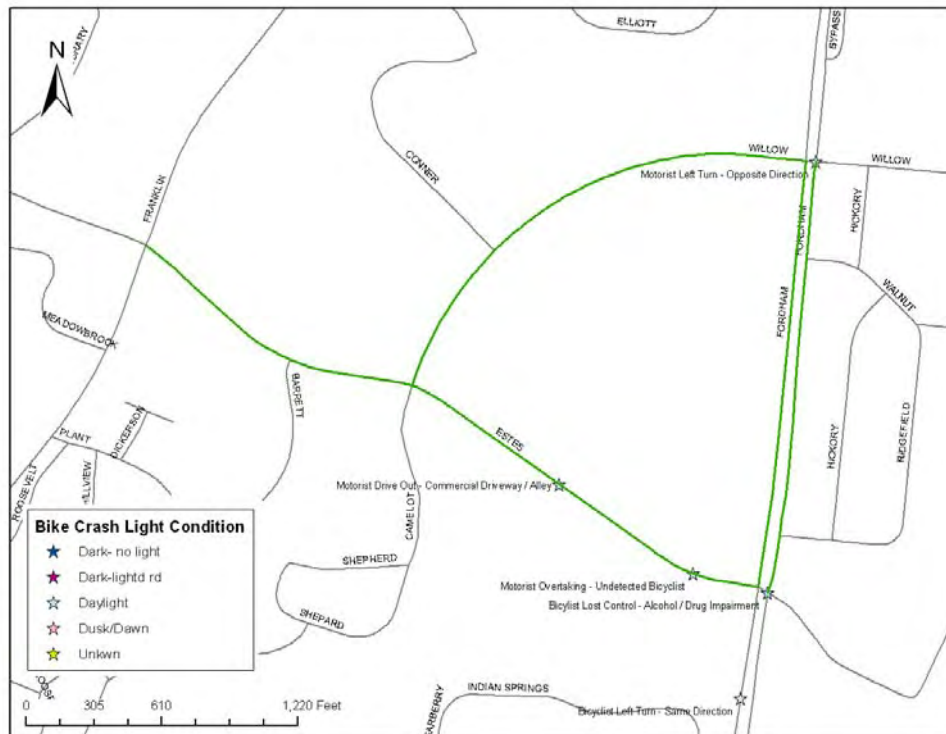
Nearly 500 pedestrians and 96 bicyclists were observed at Estes and Community Center Dr in a 2005 daily (12 hour) count. The number of pedestrians seems to have increased considerably at Community Park since the original 2001 count when there were ~190 pedestrians in a 12 hour count. Sidewalks are provided on both sides of Estes along with a narrow grass buffer, although it is not continuous on the south side, ending near a bus stop east of Camelot Dr and cutting off a housing unit (Brookwood Apts.) and another transit stop closer to Fordham Blvd. A beaten path continues through this section. The older sidewalk sections also have some issues with uneven pavement, cracks, etc. that could present difficulties to senior pedestrians or pedestrians with disabilities. At driveway crossings, there are sometimes drop-offs/damaged pavement, and uneven slopes. Since the sidewalk slopes to the driveway level at most driveway crossings, particularly on the north (older) side, improperly designed curb ramps may also make travel difficult for pedestrians with disabilities. Steep lips at driveways also create challenging turns into these driveways for bicyclists. Both pedestrians and bicyclists were struck by motorists exiting driveways in this area. The bicyclist was riding facing traffic on the sidewalk. However, another bicyclist was struck by an overtaking motorist when riding properly in the direction of traffic in the travel lane (Figure 56). Both crashes occurred during daylight hours – the latter one during the morning traffic peak.

Figure 56. Estes audit area and bike crash locations.

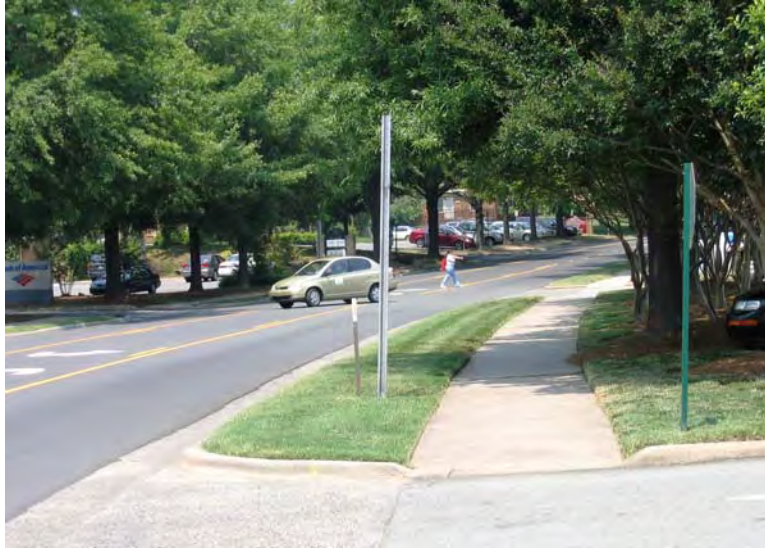
- The center turn lane does not provide refuge for crossing pedestrians who are vulnerable to through and turning motorists at the numerous driveways ().
- Most of the driveway crossings along this road are very wide and at street level, rather than at sidewalk level, increasing pedestrian exposure and allowing for fast turns at these locations.

Figure 57. Pedestrian crossing midblock on Willow Drive while vehicle turns out of driveway.

Note: The two-way left turn lane and many driveways, mean pedestrians crossing midblock are exposed to turning and through traffic. Note: a midblock crosswalk has recently been installed further northeast of this location.

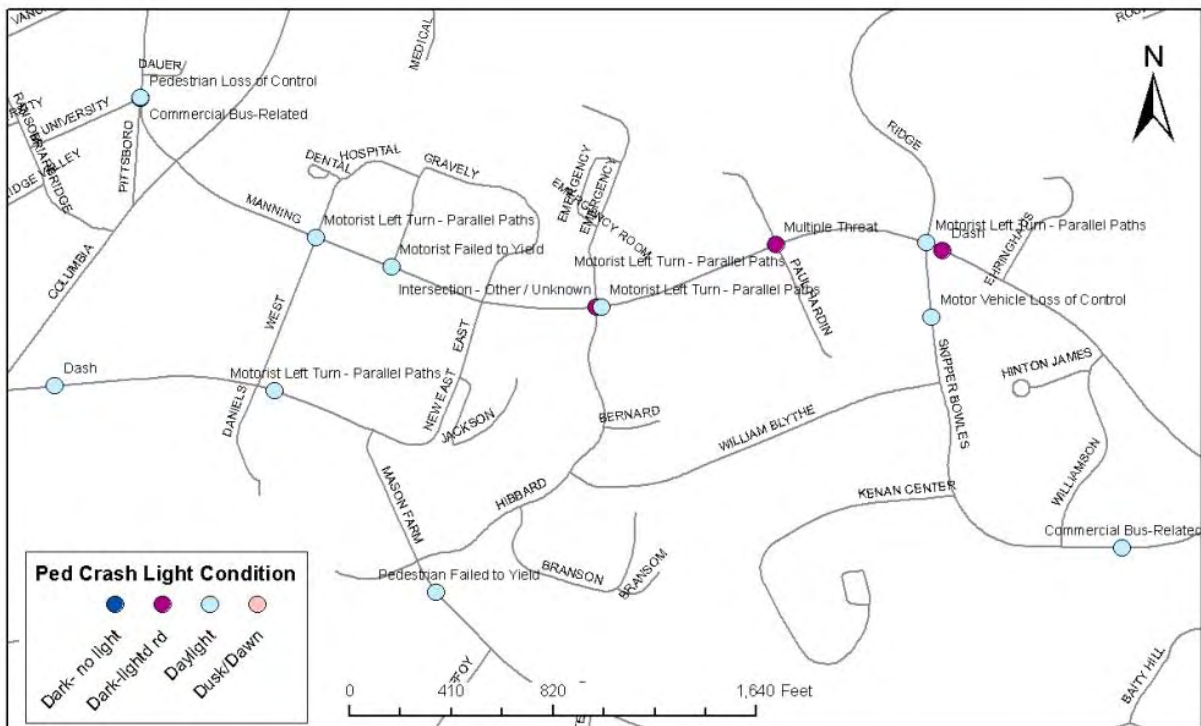
There have been 10 pedestrian collisions along the audited portion over the study period, all of them at or near intersections. A number of the collisions involved left turning motorists failing to yield to pedestrians in crosswalks (see Figure 58). Two bicyclist collisions also occurred at intersections.

Figure 58. Audited areas of Manning Dr illustrating pedestrian crash locations.

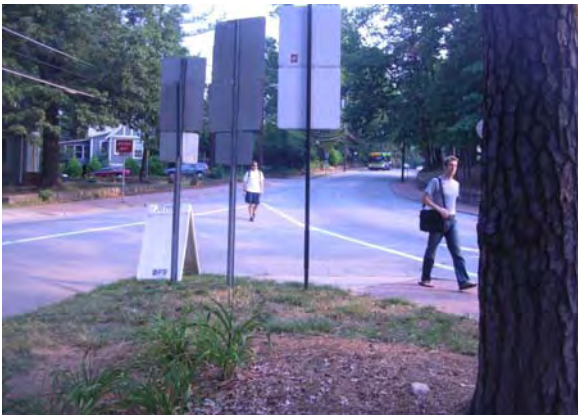
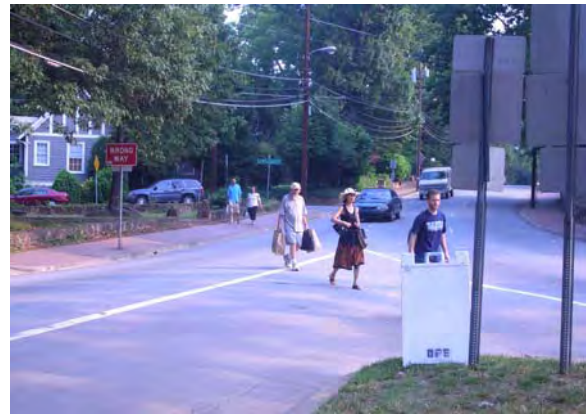
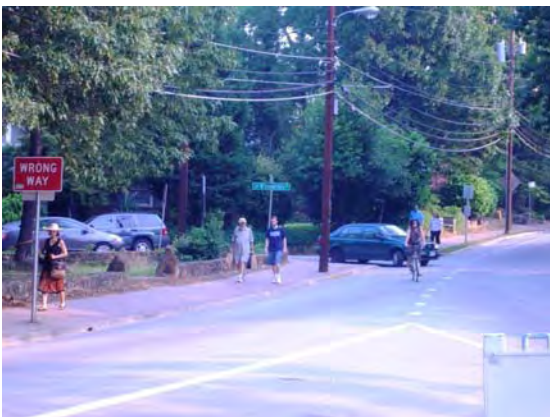
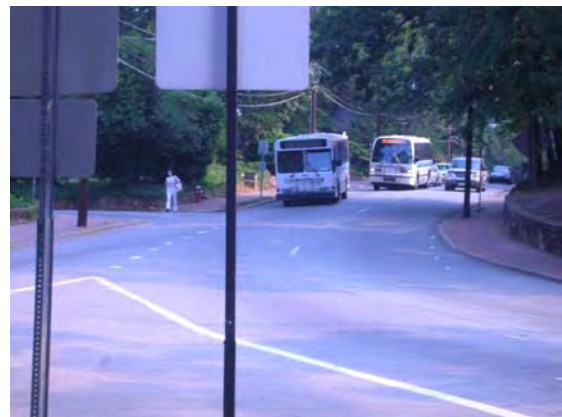
This area is in need of improvements to help pedestrians and bicyclists travel safely to and from transit stops and from nearby neighborhoods to campus destinations. Pedestrians crossing Pittsboro face traffic weaving and changing lanes to get around stopped buses and to position for heading south on Columbia or east on Manning prior to the splitter island. The west side lane can be used to continue south on Pittsboro to Columbia or to go east on Manning. Since both lanes have the option to continue east on Manning, pedestrians may falsely assume that vehicles in the west lane of Pittsboro are 'turning' east and step out to cross Pittsboro (see images in Figure 60). Additionally, while there is a curb cut on the east side (on the island) of Pittsboro, the sidewalk on the west side of Pittsboro ends at North St and there is no sidewalk or curb ramp to provide safe access for pedestrians with disabilities crossing at the splitter island or for pedestrians heading south on Pittsboro towards S Columbia (Figure 61).

Figure 60. Many pedestrians cross the single, southbound lane of Pittsboro (left of splitter island in top left photo). (Photos by Charlie Zegeer)

Note: The current location of the bus stop (lower right) also contributes to visibility problems and weaving in advance of the crossing area.

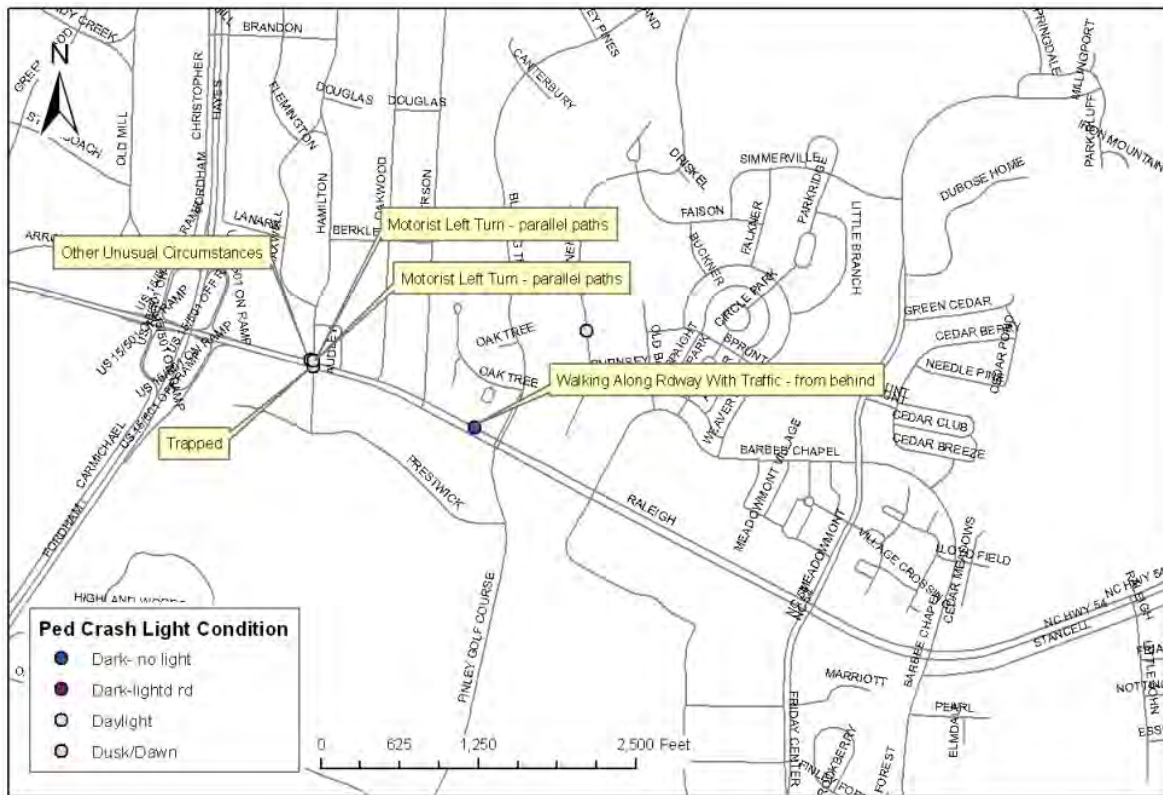
Figure 67. Raleigh Rd/NC 54 audit areas and pedestrian crash locations.

The area of interest is an approximate 1.2 mile segment from U.S. 15/501 to Barbee Chapel Rd (E). It was identified from a number of pedestrian and bicycle crashes, predominantly in the area of the intersection with Hamilton Rd (see Figure 67 to view the locations and types of pedestrian collisions). The Town of Chapel Hill also focused attention on three other intersections along the corridor including those at Barbee Chapel E, Meadowmont Lane/Friday Center Dr, and Burning Tree/Finley

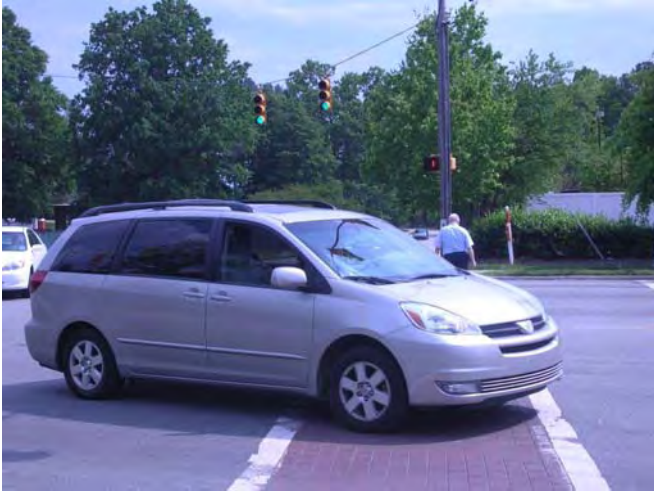
Figure 69. Turning vehicles threaten pedestrians at Raleigh Rd and Hamilton Rd.

- There is no protected left turn phase on the Hamilton legs (substantial traffic leaving shopping center on the south side and the large residential neighborhood north side), so substantial numbers of turning motorists often conflict with crossing pedestrians (Figure 69).

- ⇒ Given several crashes involving motorists turning from Hamilton onto NC 54 who failed to yield to pedestrians in crosswalks, add protected left turn phasing following the through phase for motorists on Hamilton.

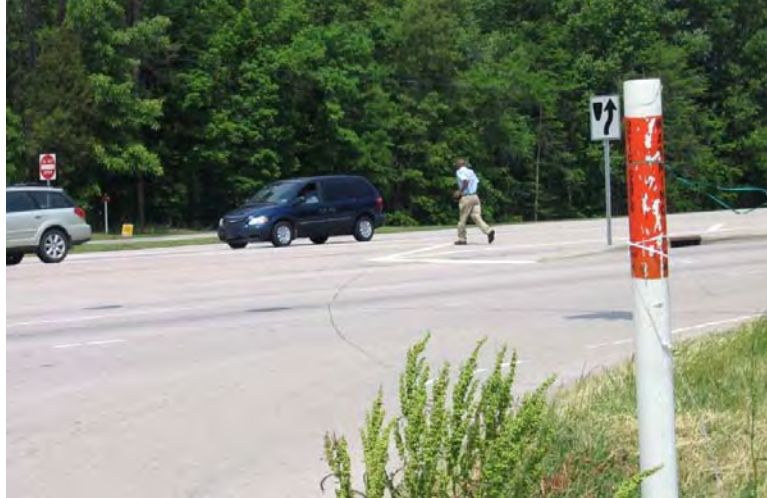
Although there are no sidewalks on Barbee Chapel south side, there are beaten paths along the road demonstrating the presence of pedestrians. Pedestrians were observed dashing across four lanes in one direction, waiting in the median, and then dashing across the opposite-direction lanes at a non-intersection location – perhaps the best option at present, although given the high speed traffic, not an adequate one (Figure 72).

Figure 72. Pedestrian dash across Raleigh Rd near Barbee Chapel E.

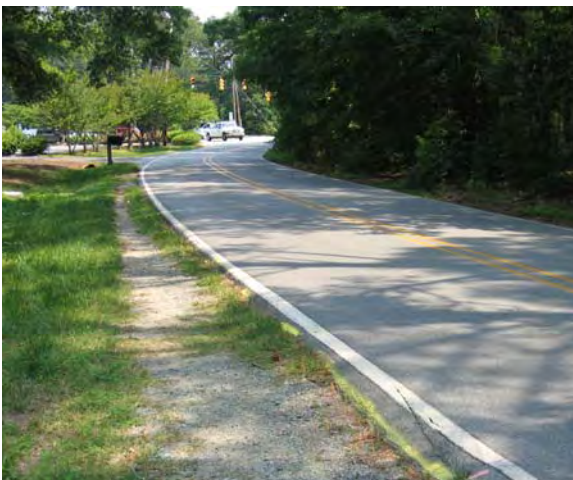
There also seems to be significant cut-through traffic using Finley Golf Course Rd. There may be issues in the future with path traffic having difficulty crossing this side street at certain times of day if the cut through traffic continues to use this route and motorists do not yield or stop on red in advance of the crosswalk area (especially notable in right turn on red maneuvers). In addition, a right turn lane is presently being added to Finley Golf Course Rd. There may also be poor sight lines from Finley Golf Course Rd to the path traffic due to vegetation and road curvature. Sight lines should be corrected as per AASHTO Green Book recommendations for the speed of traffic. (Since the right-turn lane addition and removal of many trees, this problem may have been corrected.) There were no signs on Finley Golf Course Rd to warn of the path crossing (see Figure 74).

Figure 74. View of of Finley Golf Course Rd on approach to Raleigh Rd and adjacent path.

- ⇒ Add cross walks and pedestrian signals to all legs of the intersection. Again, consider the separate phasing of left turns and pedestrian intervals.
- ⇒ Add bicycle detection to Finley Golf Course Rd and Burning Tree.
- ⇒ Consider the placement and visibility of crosswalks in light of the path ending.
- ⇒ Provide adequate lighting at the intersection.
- ⇒ Use advanced stop bars to improve sight distance and perhaps provide some protection from multiple threat crashes. This may also allow bicyclists to move to the front of stopped traffic in order to position for left turns.
- ⇒ Improve or add properly-designed accessible pedestrian landings and ramps in line with crosswalks.

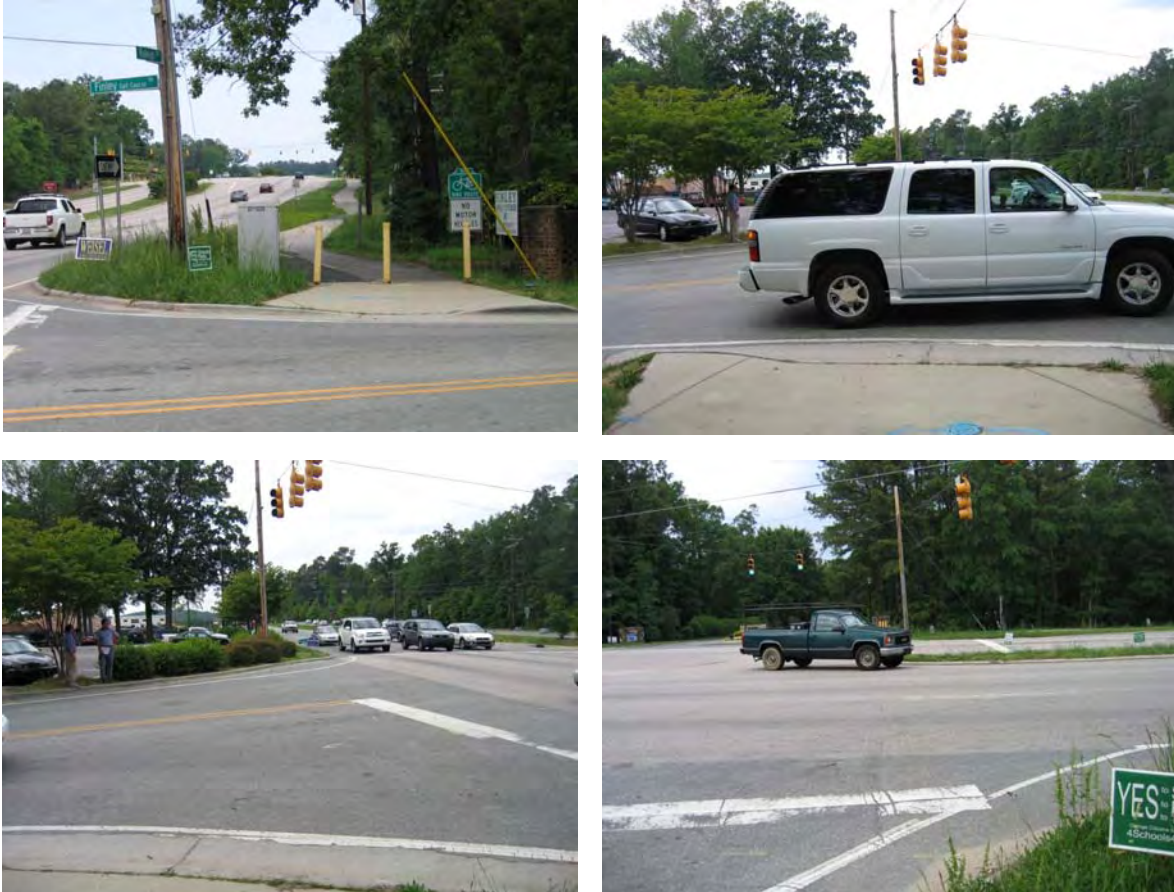
As at Barbee Chapel, there are no crosswalks or pedestrians signals across Raleigh Rd/ NC 54 OR across the side streets at this location. The multi-use path also comes to an abrupt end at Finley Golf Course Rd on the south side of NC 54, and there is no walkway or path continuing west of Finley Golf Course Rd (see images in Figure 75). Therefore, pedestrians and bicyclists using this path are essentially left with no way to cross Raleigh Rd and no way to continue on the south side. There are continuous sidewalks on the north side of Raleigh Rd.

Figure 75. Images of the start/end of the NC 54 sidepath at Finley Golf Course Rd.

Note: There are no crosswalks or pedestrian signals in any direction for pedestrians and bicyclists to continue from or gain access to the end of the path.

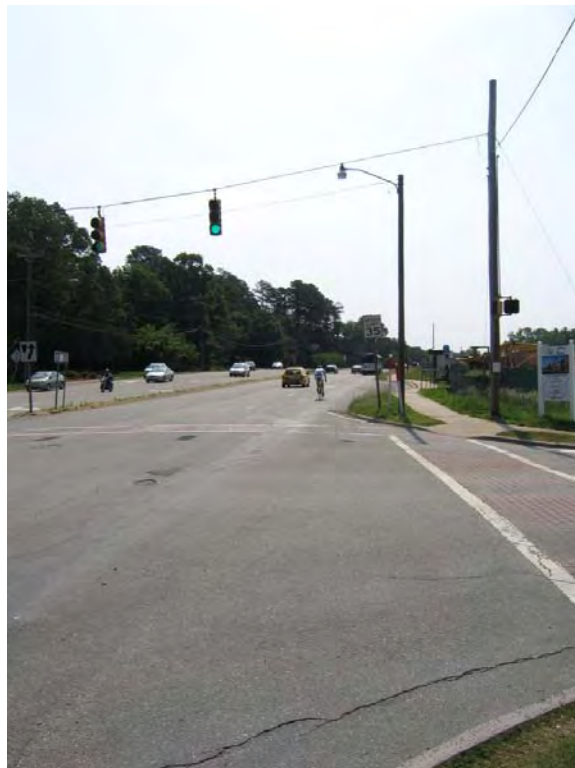
Figure 78. Another cyclist uses the street during a period of lighter traffic.

- ⇒ As discussed previously, a combined bike/bus, and limited right-turn only lane could potentially be a solution as done in Madison Wisconsin on a high-volume corridor, with bicyclists encouraged to take the lane through signing and other measures. (Madison has since provided separate bus/bike facilities on this corridor more similar to that described in the first bullet.) As discussed previously the ongoing through, right-turn lane with high speed traffic may provide a difficult sharing situation for many bicyclists and also contributes to hazards from turning vehicles for through bicyclists (as seen with a crash at Hamilton), as well as sidewalk and wrong-way riding.
